Walnut Street

Address: 54 Walnut Street

Approximate/Documented Date of Building: 1880

Surveyed: 8/17/2018

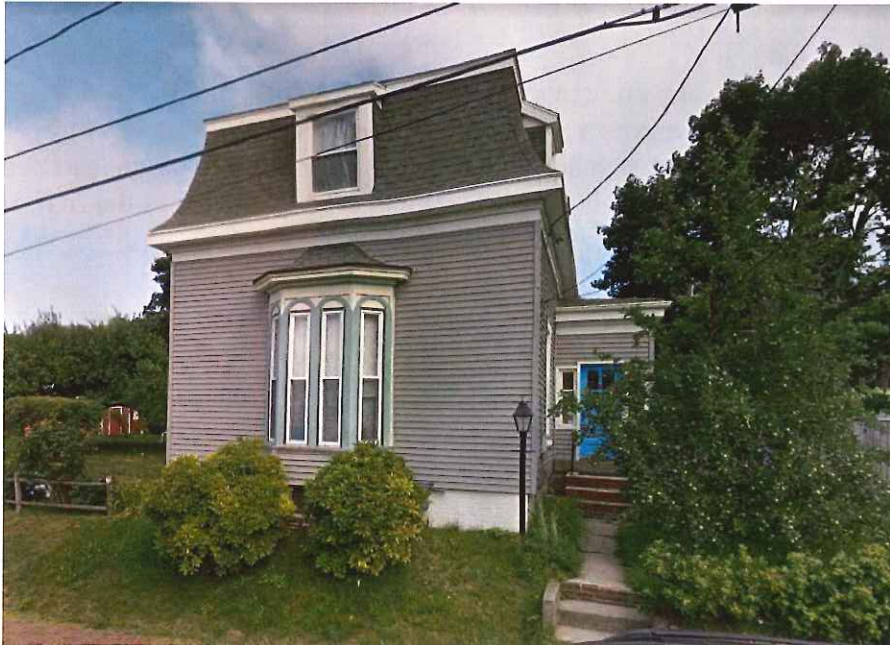
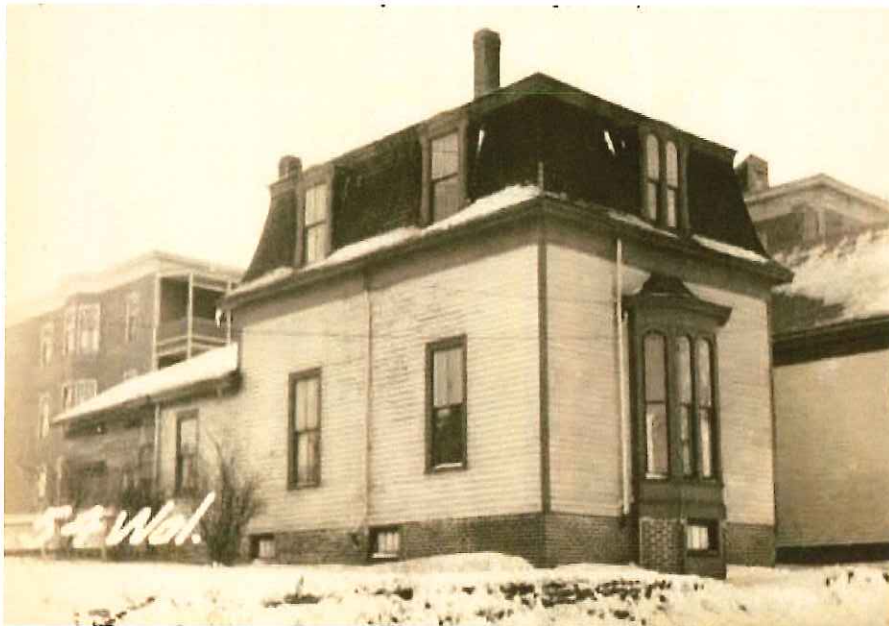
54 Walnut Street is a good example of wooden frame Second Empire home built on Munjoy Hill in the late nineteenth century. Although it has received some alterations, the asymmetrical, one-and-a-half story, single-family home with mansard roof boasts many of its original details. Distinguishing features include a sloped roof between the curbs, shed dormer windows, a bay window with wooden arch details, and a projected main entry vestibule.

The dwelling is one by three bays including one-story rear ell, and has replacement 1/1 vinyl sash windows. The façade's bay window boasts a curved hood (mirroring the dwelling's roof) and four 1/1 windows with wooden arched detailing, which are remnants of the original arched lights. The main entrance sits in the dwelling's one-story vestibule, which extends to the rear ell. The dwelling's eaves have vinyl casings.

The roof is asphalt and its shed dormers also feature replacement 1/1 vinyl sash windows. The upper slope is hipped and has one chimney at the interior ridge.

Common alterations to 54 Walnut Street since 1924 include windows, wooden clapboard siding and loss of wooden paneling and arched lights in the façade's bay window. The dwelling's shed dormers also once boasted arched entablatures, and an arched window pair over the façade. Despite these losses the dwelling retains several defining features that contribute to the neighborhood's historic character.
